Post Installation Report

Witheridge Parish Council

Witheridge Adventure Playground

Inspection Ref: 2061667

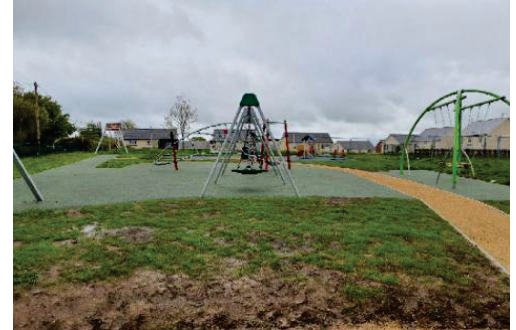
Item: Site General
Manufacturer: Owner/Operator
Surface Type: N/A
Item Quantity: 1
Equipment Compliance: N/A
Surface Area Compliance: N/A

It is recommended that signage, with information including the site address, contact information for maintenance issues and emergency contact details are provided for the facility - Provide in accordance with the recommendations

There are materials and debris remaining on site, the site is temporarily fenced in the most part however the fencing does not fully restrict access suggesting the site is open for use - Ensure site access is appropriately managed until works are fully completed

The separation between the play equipment and fitness equipment is approximately 15m; the areas are segregated by a bow top fence however the fitness equipment is located adjacent to the play area access footpath presenting some potential for use by younger children - Monitor use and ensure that there is an appropriate design risk assessment in place

The surface is uneven in places around the edges of the wet pour surface - Reinstate the grass surface to level

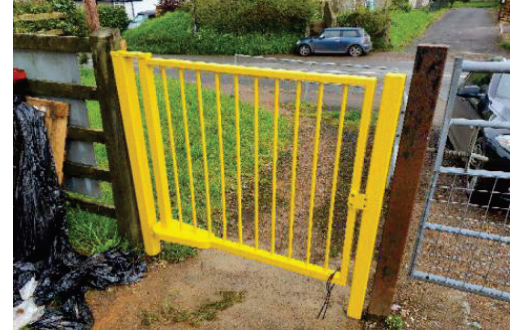
Item: Gate - Self Closing
Manufacturer: I.A.E. Fencing
Surface Type: Mixed Surface
Item Quantity: 1
Equipment Compliance: N/A
Surface Area Compliance: N/A

The gate is closing too slowly (in excess of 8 seconds) -
 Take effective action to ensure the gate closes between 4
 and 8 seconds

The approach path is worn and there are trip hazards
 present - Reinstate the surface

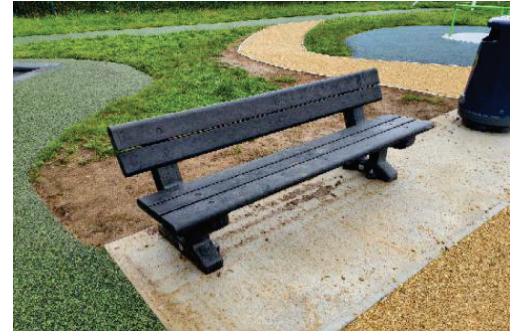
Item: Bench
Manufacturer: Glasdon
Surface Type: Concrete
Item Quantity: 1
Equipment Compliance: N/A
Surface Area Compliance: N/A

There are projecting bolt thread(s) present - Remove excess thread length and deburr or provide cap

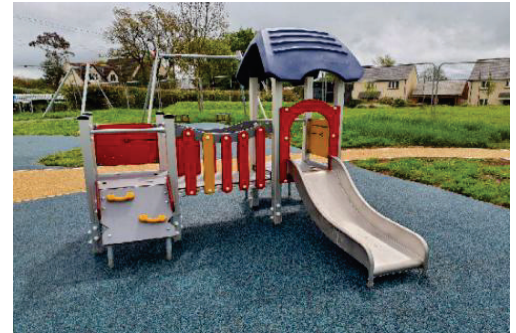
Item: Multi Play (Toddler)
Manufacturer: Kompan Ltd
Surface Type: Wet Pour
Surface Nominal Depth: 75mm
Item Quantity: 1
Equipment Compliance: No
Surface Area Compliance: Yes
Total Findings: 2

There is/are bolt cap covers missing or damaged on the item - Replace missing or damaged bolt cap covers

The item has been installed marginally too high which has resulted in the platform height being in excess of 600mm (630mm) and technically, the height of the barriers (550mm) are now insufficient to meet the requirements of BS EN 1176 Part 1. This is however a very low risk technicality and no remedial action is recommended as it has not affected the risk assessment of the item - No action given the risk assessment

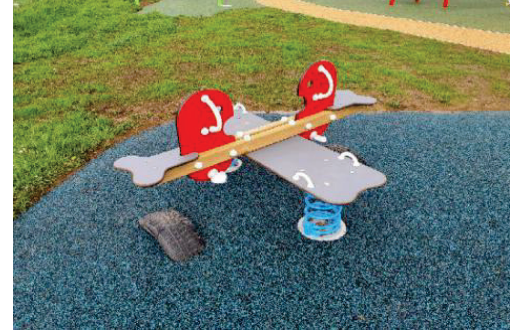
Item: Spring See-Saw
Manufacturer: Kompan Ltd
Surface Type: Mixed Surface
Surface Nominal Depth: 120mm
Item Quantity: 1
Equipment Compliance: Yes
Surface Area Compliance: Yes
Total Findings: 1

The grass surface forms part of the impact area around the equipment and the surface has not yet established - Ensure that a suitable impact attenuating surface is established

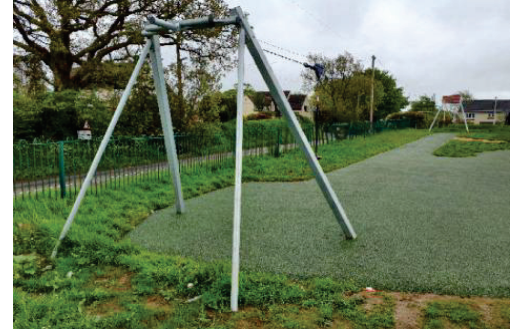
Item: Cable Runway
Manufacturer: Kompan Ltd
Surface Type: Mixed Surface
Surface Nominal Depth: 55mm
Item Quantity: 1
Equipment Compliance: No
Surface Area Compliance: No
Total Findings: 3

There is/are inserts missing - Replace missing inserts

The height of the seat is less than 350mm when loaded and does not meet the requirements of BS EN 1176 Part 4 (approximately 200mm estimated) - Ensure the seat is a minimum of 350mm above ground level when loaded with 69.5kg

The surfacing dimensions are short and do not meet with the requirements of the current applicable standard (2.0m required / 1.05m provided) - Refer to the designer / contractor

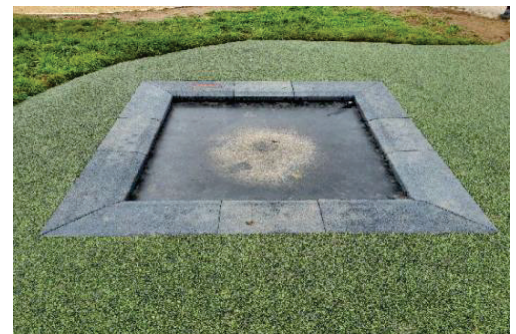
Item: Bouncing Facility
Manufacturer: Kompan Ltd
Surface Type: Wet Pour
Surface Nominal Depth: 50mm
Item Quantity: 1
Equipment Compliance: Yes
Surface Area Compliance: Yes
Total Findings: 1

On site visits it is not possible to test the ground clearance of the Bouncing Facility bed as specified in BS EN 1176; ensure that the clearance between the Bouncing Facility Bed and the ground underneath is in accordance with the manufacturers recommendations - Refer to the manufacturers recommendations

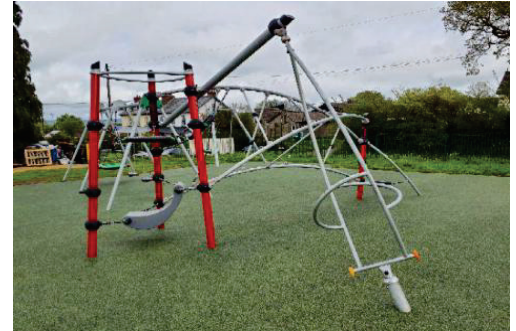
Item: Climbing Frame
Manufacturer: Kompan Ltd
Surface Type: Wet Pour
Surface Nominal Depth: 135mm
Item Quantity: 1
Equipment Compliance: Yes
Surface Area Compliance: Yes
Total Findings: 1

The grips are not fully secured - Secure

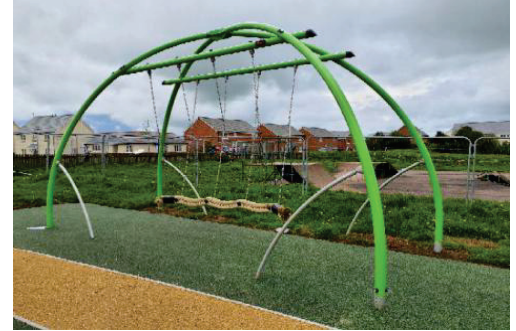
Item:	Giant Rope Swing
Manufacturer:	Kompan Ltd
Surface Type:	Wet Pour
Surface Nominal Depth:	60mm
Item Quantity:	1
Equipment Compliance:	Yes
Surface Area Compliance:	Yes
Total Findings:	1

The rope is currently bent however we understand this will straighten during initial use - Monitor initial use to ensure the rope straightens out

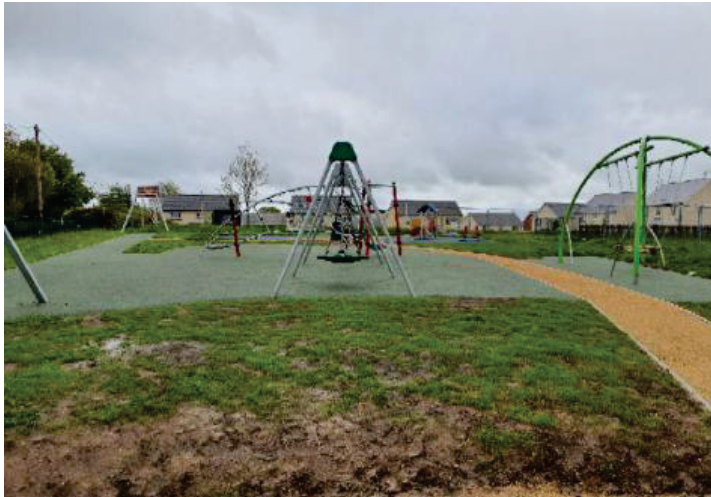
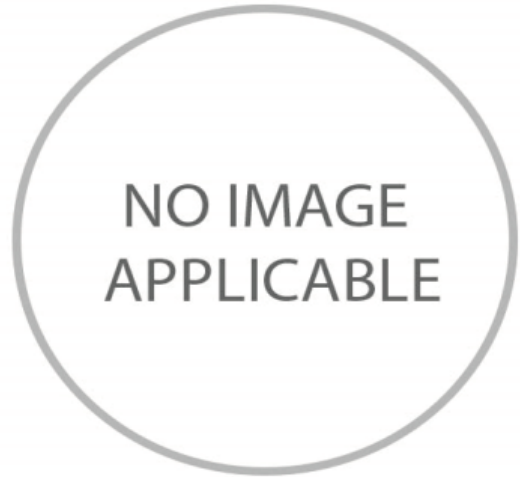
5 - Very Low Risk (Finding 1)

Finding: It is recommended that signage, with information including the site address, contact information for maintenance issues and emergency contact details are provided for the facility

Action: Provide in accordance with the recommendations

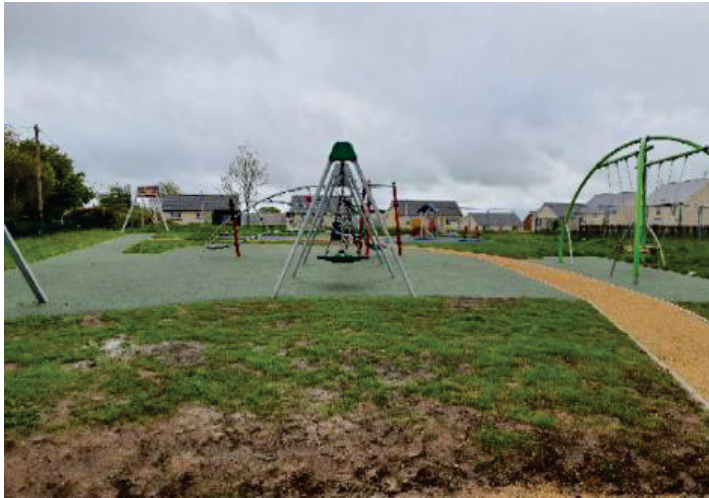
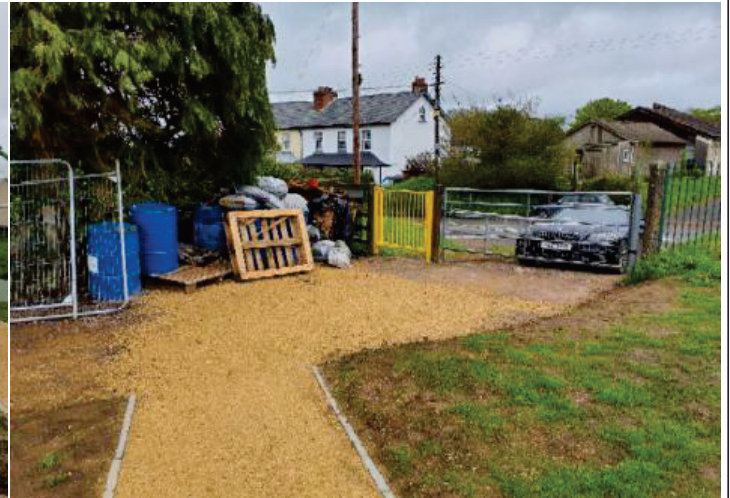
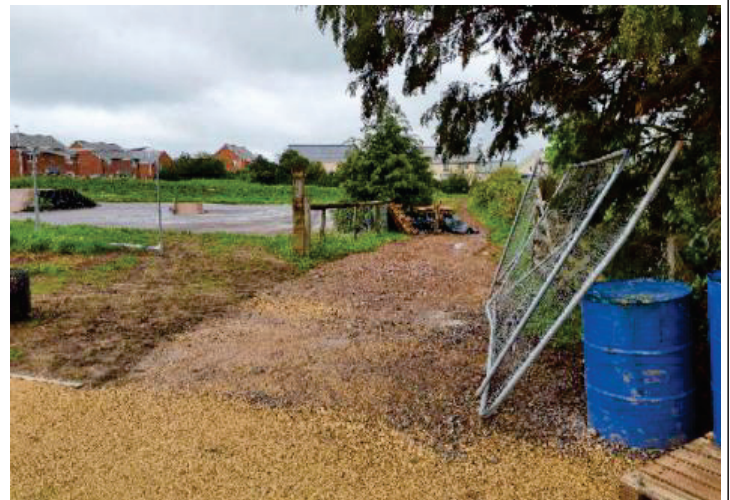
i 0 - Risk Assessment not Undertaken (Finding 2)

Finding: There are materials and debris remaining on site, the site is temporarily fenced in the most part however the fencing does not fully restrict access suggesting the site is open for use

Action: Ensure site access is appropriately managed until works are fully completed

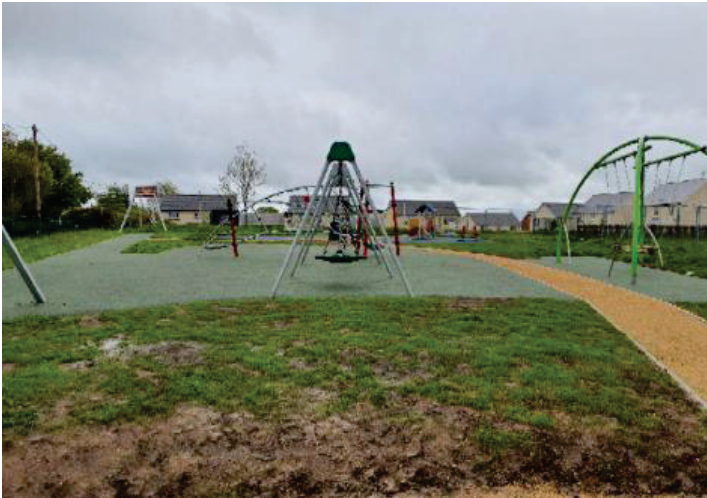
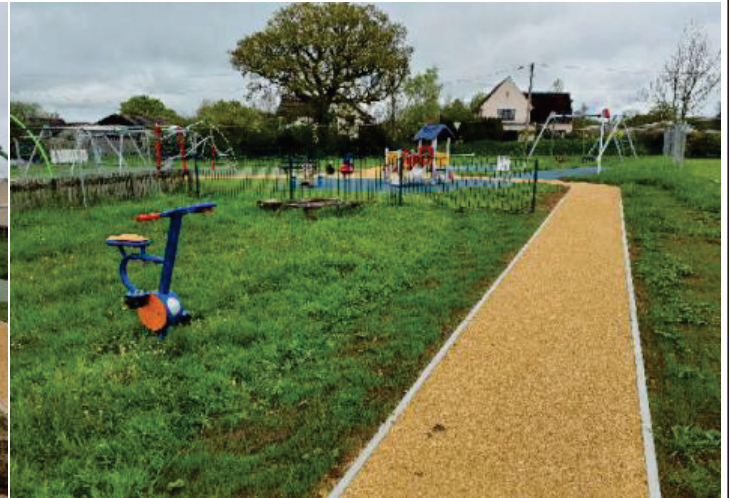
i 8 - Low Risk (Finding 3)

Finding: The separation between the play equipment and fitness equipment is approximately 15m; the areas are segregated by a bow top fence however the fitness equipment is located adjacent to the play area access footpath presenting some potential for use by younger children

Action: Monitor use and ensure that there is an appropriate design risk assessment in place

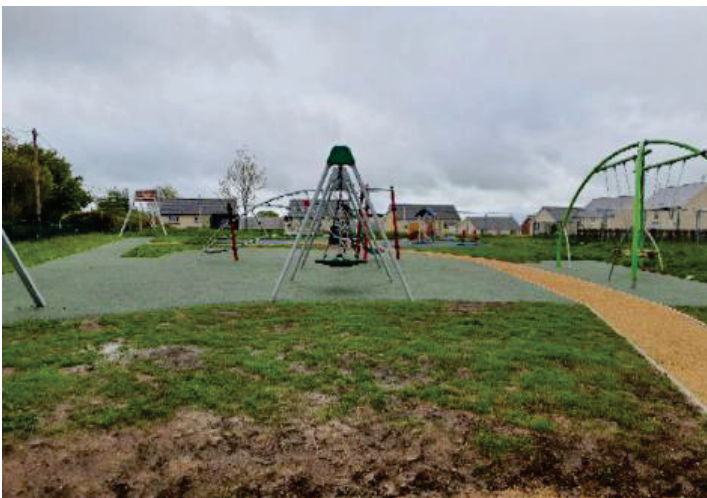
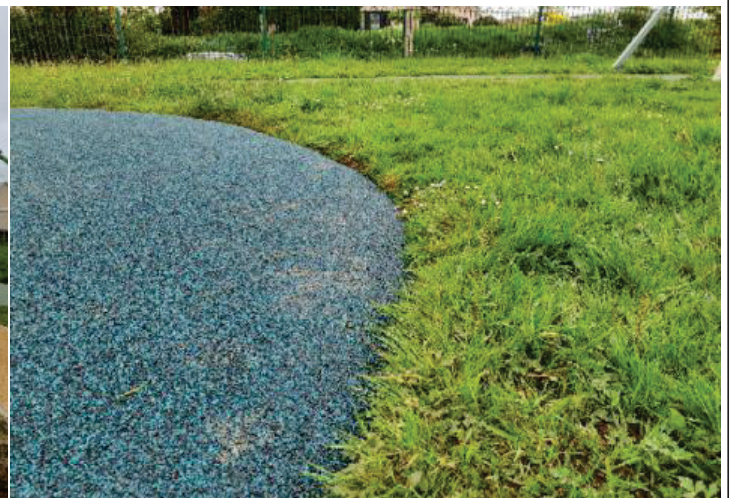
i 8 - Low Risk (Finding 4)

Finding: The surface is uneven in places around the edges of the wet pour surface

Action: Reinstate the grass surface to level

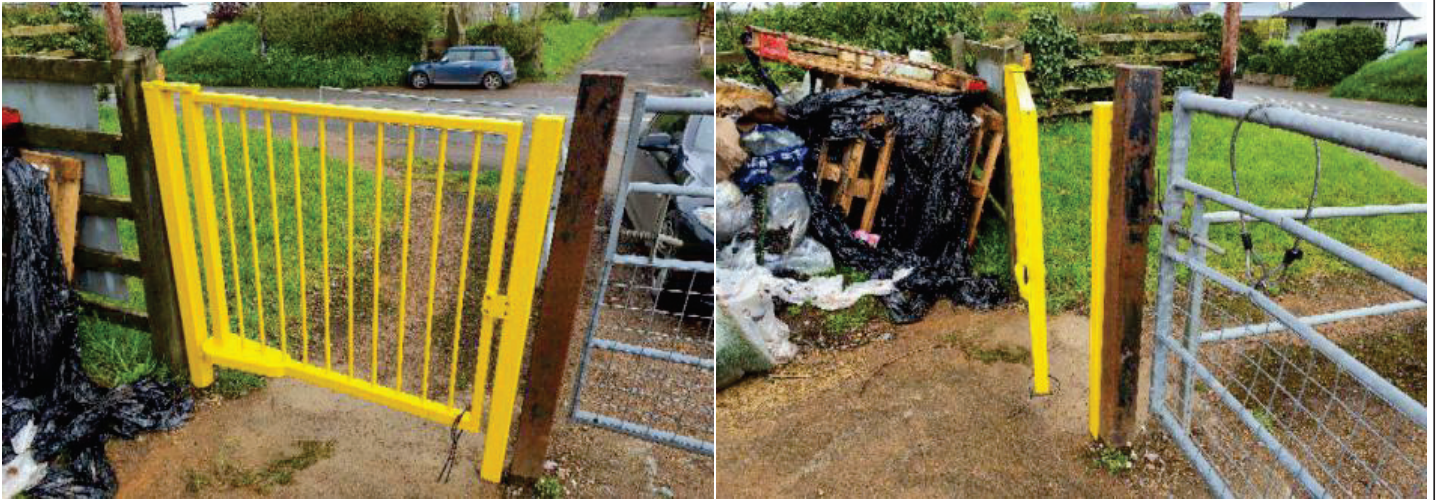
i 5 - Very Low Risk (Finding 1)

Finding: The gate is closing too slowly (in excess of 8 seconds)

Action: Take effective action to ensure the gate closes between 4 and 8 seconds

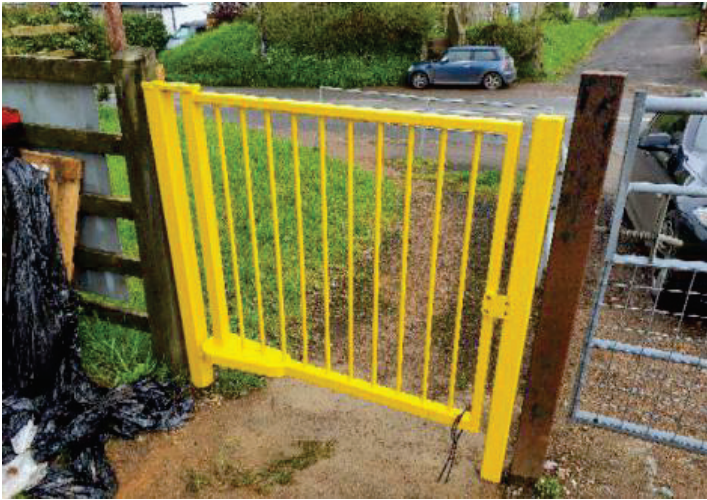
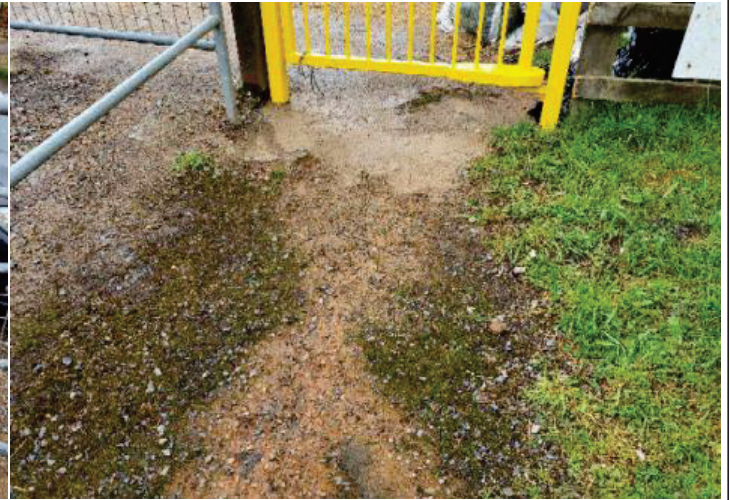
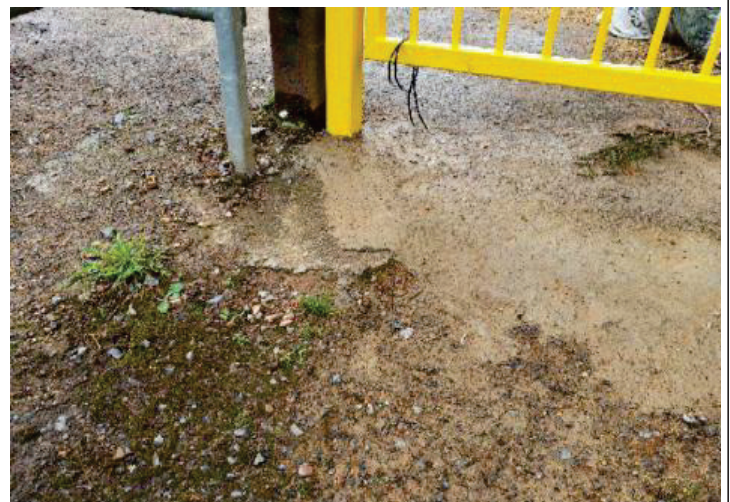
i 8 - Low Risk (Finding 2)

Finding: The approach path is worn and there are trip hazards present

Action: Reinstate the surface

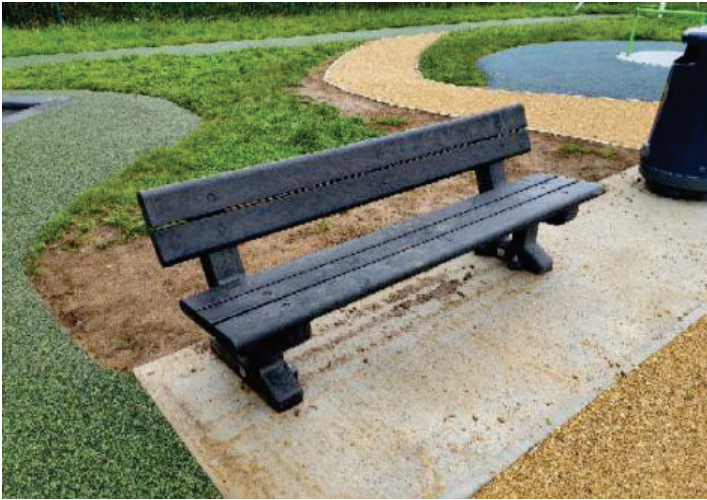
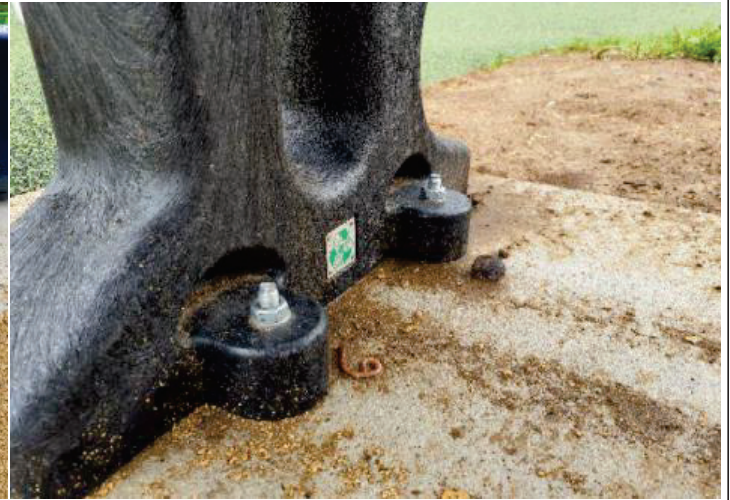
i 6 - Low Risk (Finding 1)

Finding: There are projecting bolt thread(s) present

Action: Remove excess thread length and deburr or provide cap

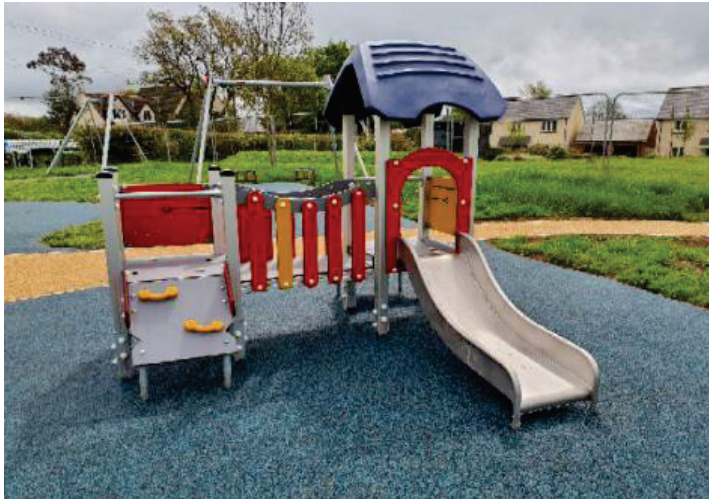
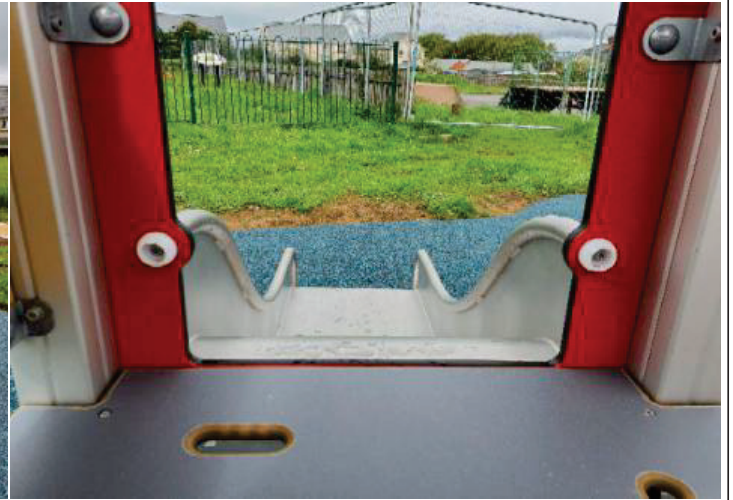
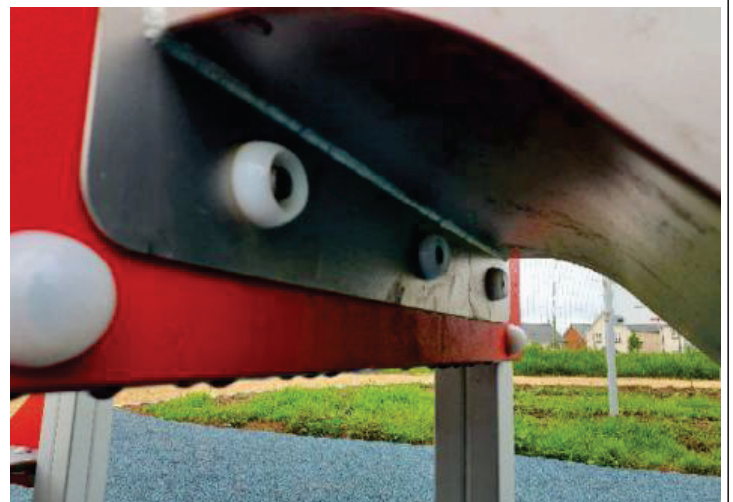
i 4 - Very Low Risk (Finding 1)

Finding: There is/are bolt cap covers missing or damaged on the item

Action: Replace missing or damaged bolt cap covers

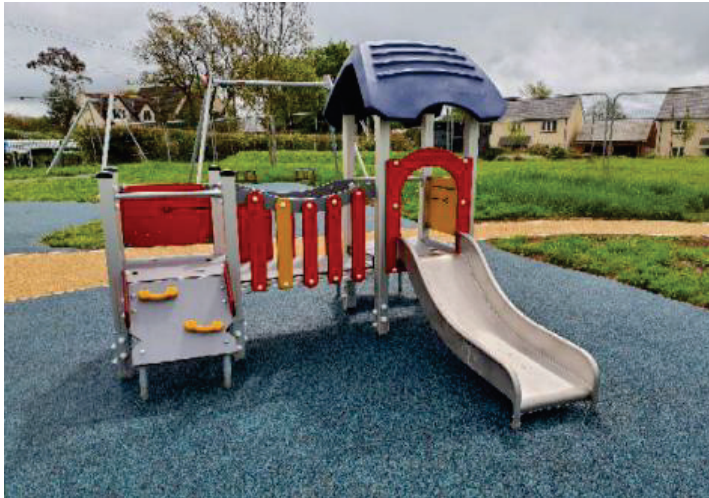
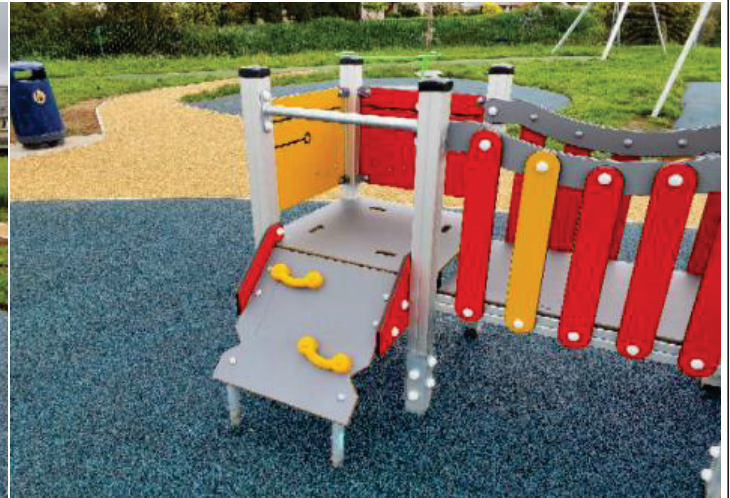
i 4 - Very Low Risk (Finding 2)

Finding: The item has been installed marginally too high which has resulted in the platform height being in excess of 600mm (630mm) and technically, the height of the barriers (550mm) are now insufficient to meet the requirements of BS EN 1176 Part 1. This is however a very low risk technicality and no remedial action is recommended as it has not affected the risk assessment of the item

Action: No action given the risk assessment

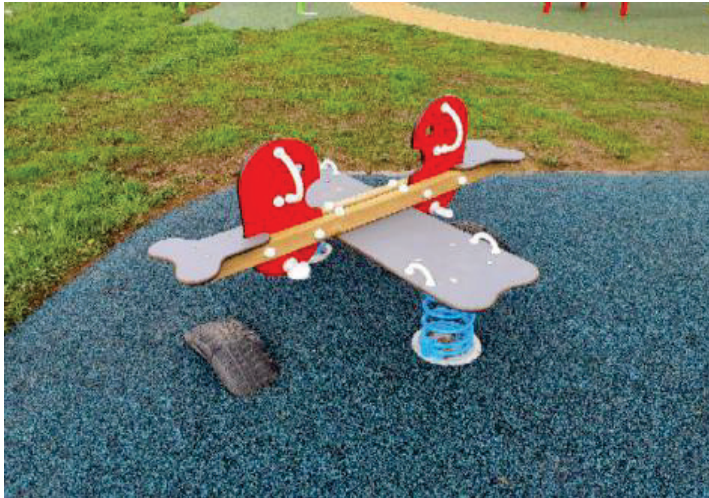
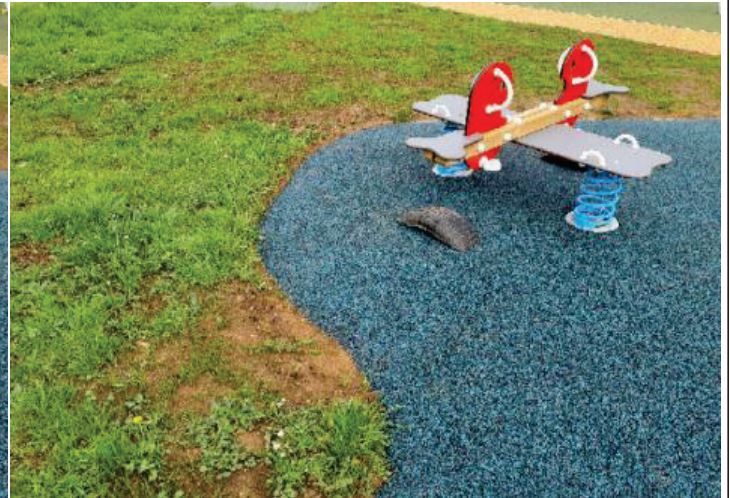
i 4 - Very Low Risk (Finding 1)

Finding: The grass surface forms part of the impact area around the equipment and the surface has not yet established

Action: Ensure that a suitable impact attenuating surface is established

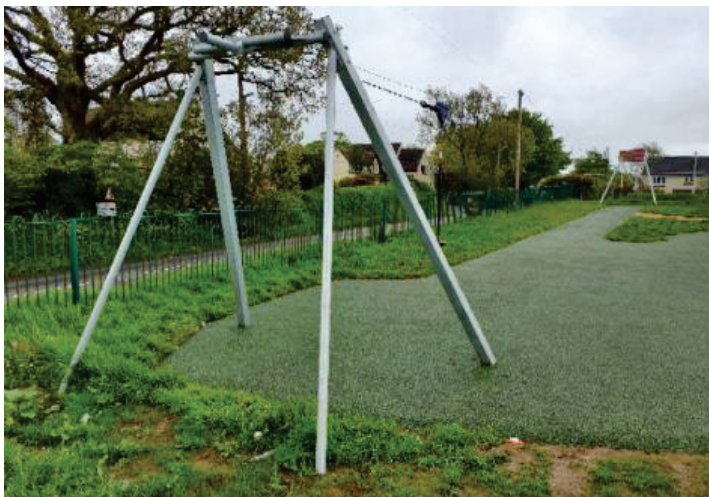
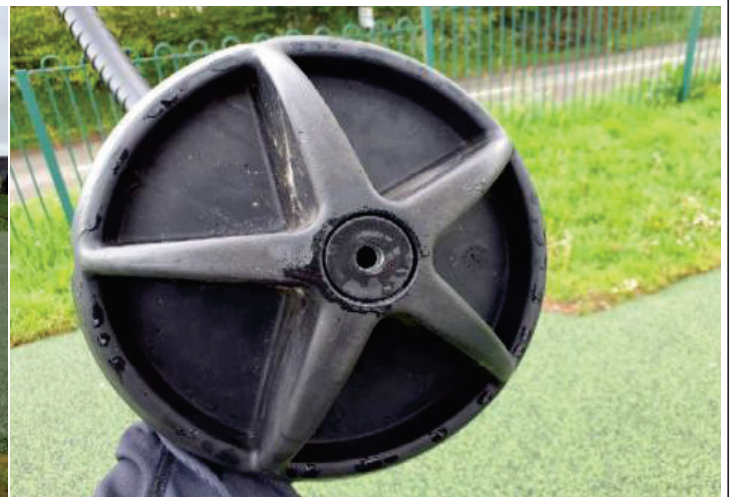
i 4 - Very Low Risk (Finding 1)

Finding: There is/are inserts missing

Action: Replace missing inserts

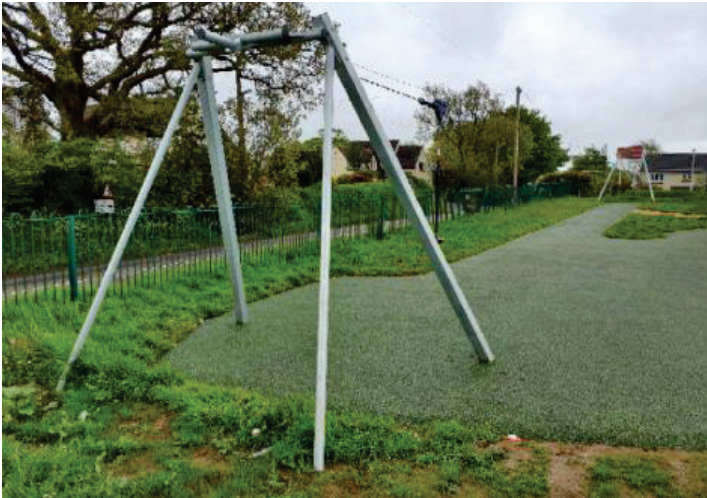
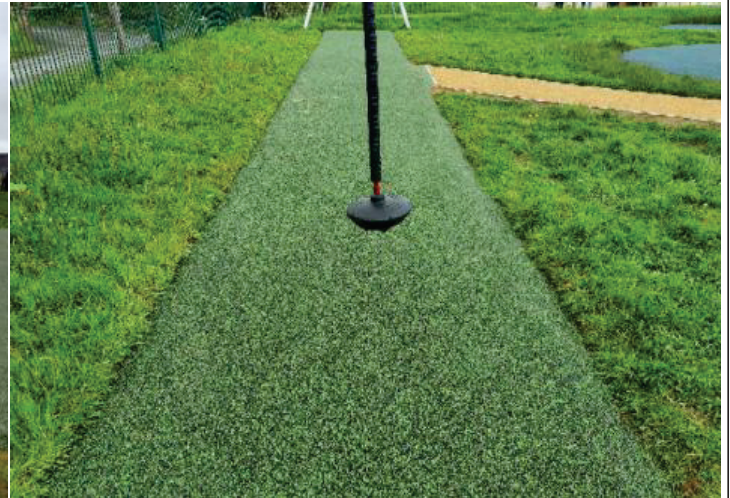
i 8 - Low Risk (Finding 2)

Finding: The height of the seat is less than 350mm when loaded and does not meet the requirements of BS EN 1176 Part 4 (approximately 200mm estimated)

Action: Ensure the seat is a minimum of 350mm above ground level when loaded with 69.5kg

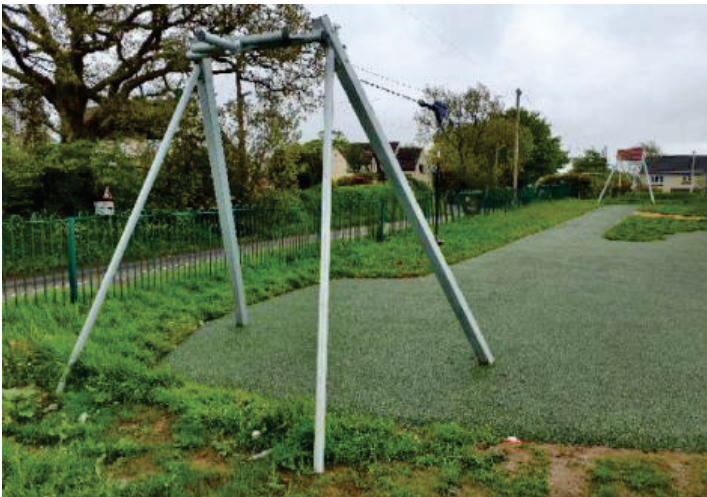
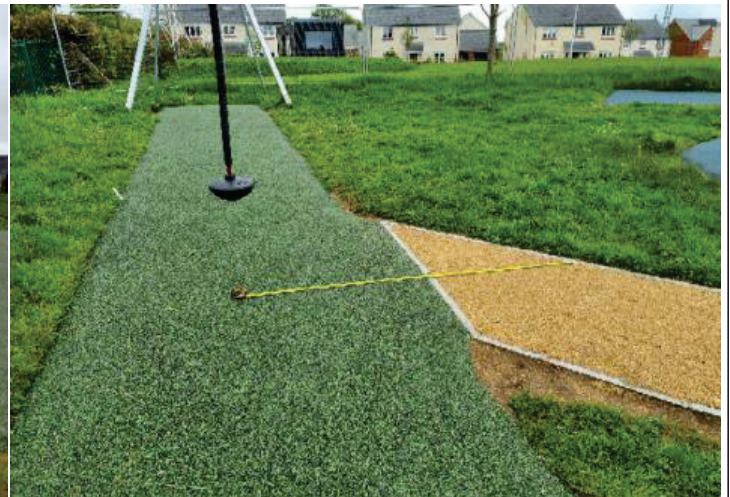
! 12 - Moderate Risk (Finding 3)

Finding: The surfacing dimensions are short and do not meet with the requirements of the current applicable standard (2.0m required / 1.05m provided)

Action: Refer to the designer / contractor

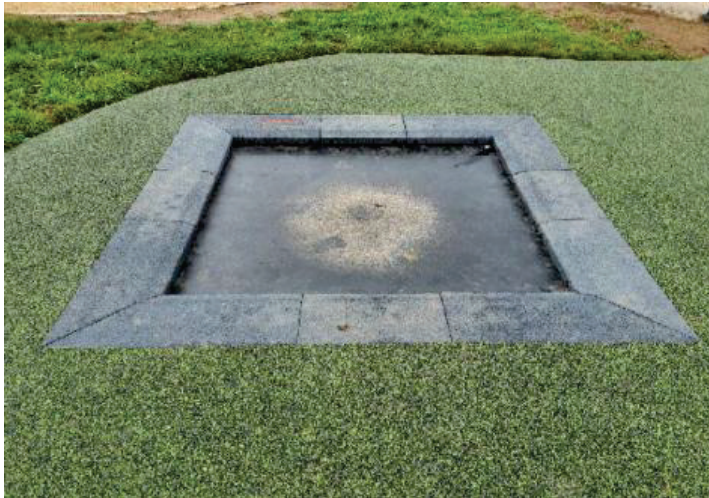
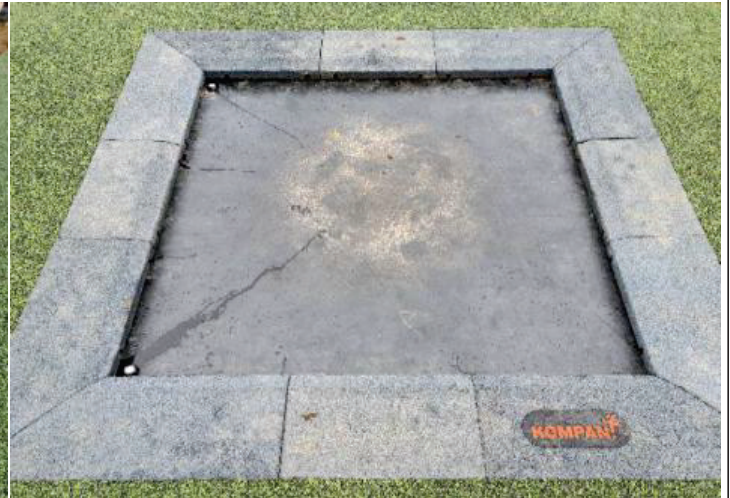
Item: Other - Bouncing Facility
Manufacturer: Kompan Ltd

Finding: On site visits it is not possible to test the ground clearance of the Bouncing Facility bed as specified in BS EN 1176; ensure that the clearance between the Bouncing Facility Bed and the ground underneath is in accordance with the manufacturers recommendations

Action: Refer to the manufacturers recommendations

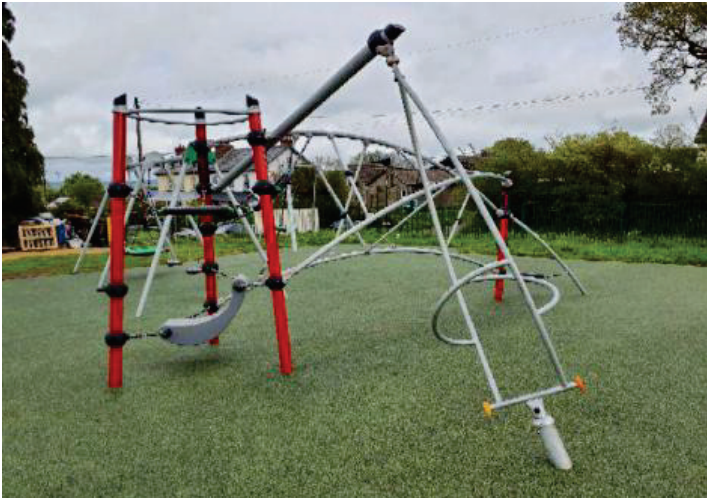
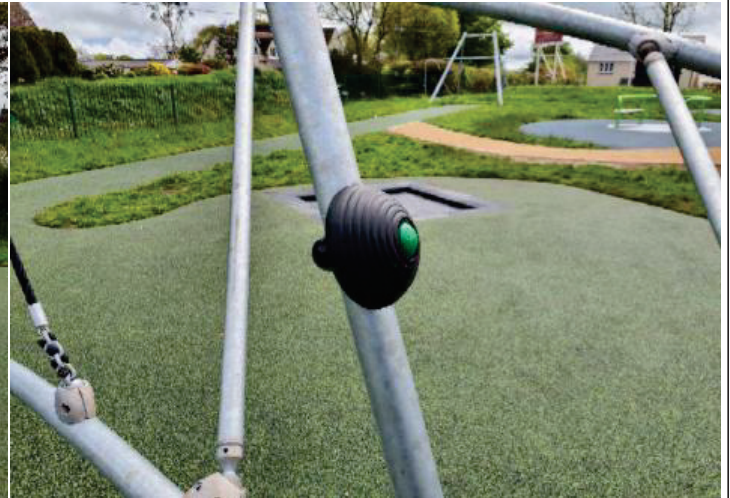
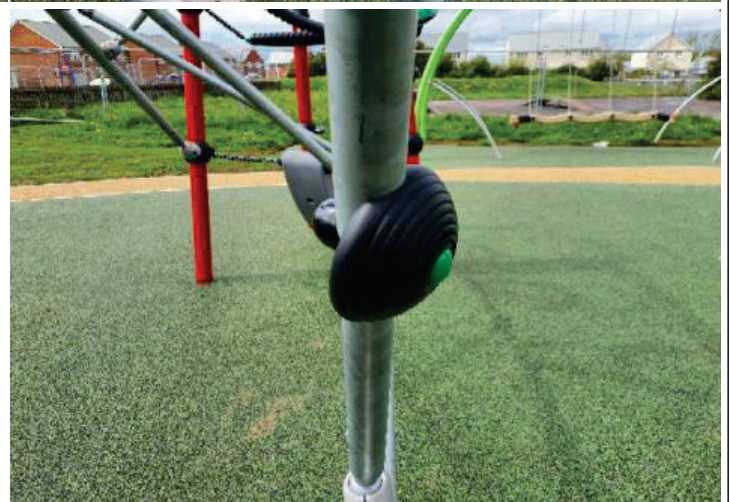
Item: Activity Equipment - Climbing Frame
Manufacturer: Kompan Ltd

Finding: The grips are not fully secured

Action: Secure

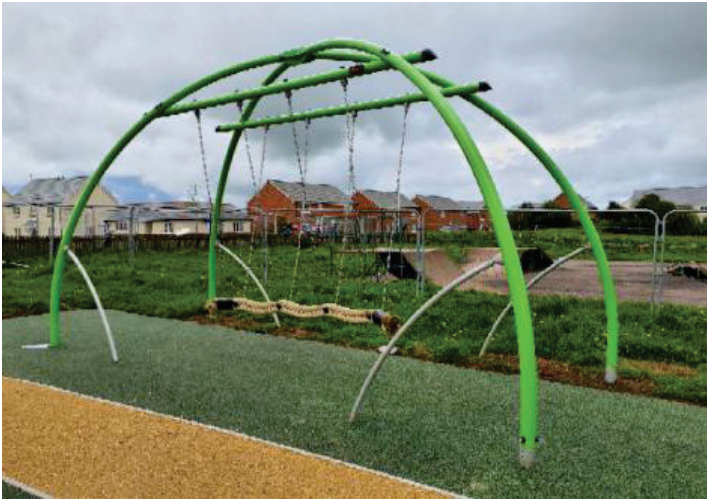
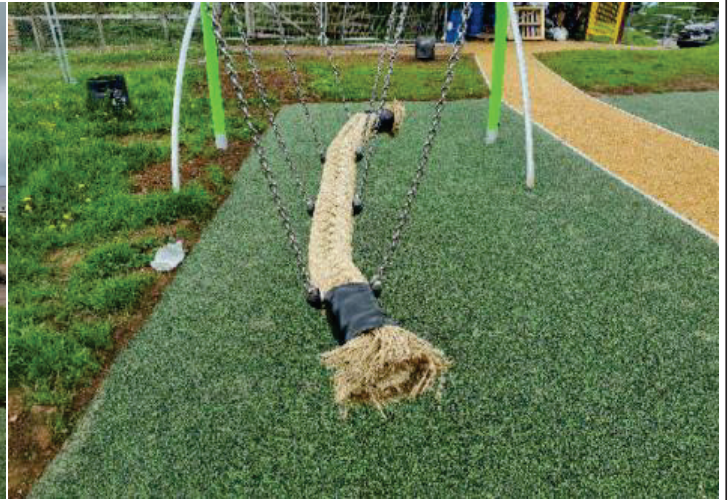
Item: Swings - Giant Rope Swing
Manufacturer: Kompan Ltd

Finding: The rope is currently bent however we understand this will straighten during initial use
Action: Monitor initial use to ensure the rope straightens out
