## Post Installation Report

Witheridge Parish Council

Witheridge Adventure Playground

Inspection Ref: 2075206

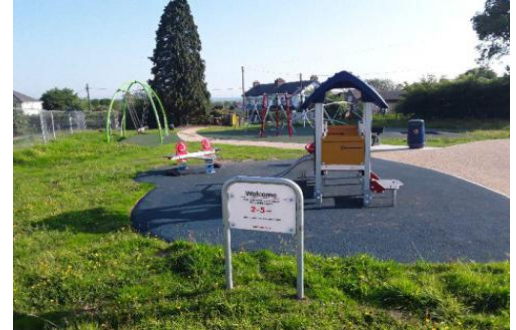
The separation between the play equipment and fitness equipment is approximately 15m; the areas are segregated by a bow top fence however the fitness equipment is located adjacent to the play area access footpath presenting some potential for use by younger children - Monitor use and ensure that there is an appropriate design risk assessment in place

The surface is uneven in places around the edges of the wet pour surface and the trenched edges could cause ankle roll injuries - Build up surfaces to remove trips

It is recommended that signage, with information including the site address, contact information for maintenance issues and emergency contact details are provided for the facility - Provide in accordance with the recommendations

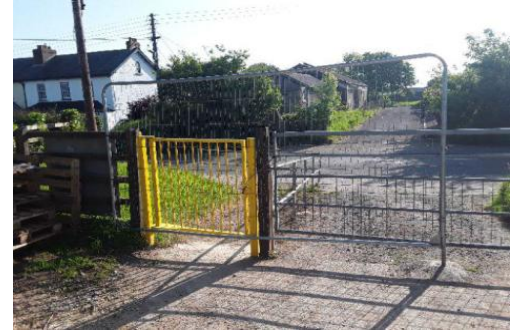
**Item:** Gate - Self Closing  
**Manufacturer:** I.A.E. Fencing  
**Surface Type:** Mixed Surface  
**Item Quantity:** 1  
**Equipment Compliance:** N/A  
**Surface Area Compliance:** N/A

The gate/s was / were locked or secured at the time of the inspection and a full inspection could not be undertaken - Complete inspection of gate/s when re-opened

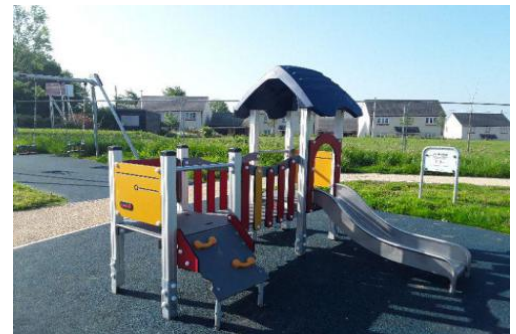
**Item:** Multi Play (Toddler)  
**Manufacturer:** Kompan Ltd  
**Surface Type:** Wet Pour  
**Surface Nominal Depth:** 75mm  
**Item Quantity:** 1  
**Equipment Compliance:** No  
**Surface Area Compliance:** Yes  
**Total Findings:** 1

The item has been installed marginally too high which has resulted in the platform height being in excess of 600mm (630mm) and technically, the height of the barriers (550mm) are now insufficient to meet the requirements of BS EN 1176 Part 1. This is however a very low risk technicality and no remedial action is recommended as it has not affected the risk assessment of the item - No action given the risk assessment

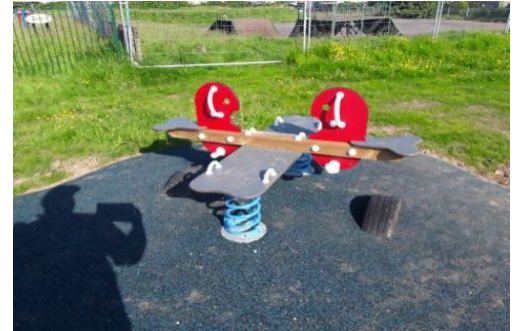
**Item:** Spring See-Saw  
**Manufacturer:** Kompan Ltd  
**Surface Type:** Mixed Surface  
**Surface Nominal Depth:** 120mm  
**Item Quantity:** 1  
**Equipment Compliance:** Yes  
**Surface Area Compliance:** Yes  
**Total Findings:** 1

The grass surface forms part of the impact area around the equipment and the surface has not yet established - Ensure that a suitable impact attenuating surface is established

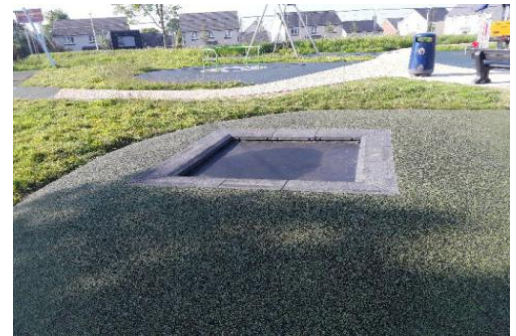
**Item:** Bouncing Facility  
**Manufacturer:** Kompan Ltd  
**Surface Type:** Wet Pour  
**Surface Nominal Depth:** 50mm  
**Item Quantity:** 1  
**Equipment Compliance:** Yes  
**Surface Area Compliance:** Yes  
**Total Findings:** 1

On site visits it is not possible to test the ground clearance of the Bouncing Facility bed as specified in BS EN 1176; ensure that the clearance between the Bouncing Facility Bed and the ground underneath is in accordance with the manufacturers recommendations - Refer to the manufacturers recommendations

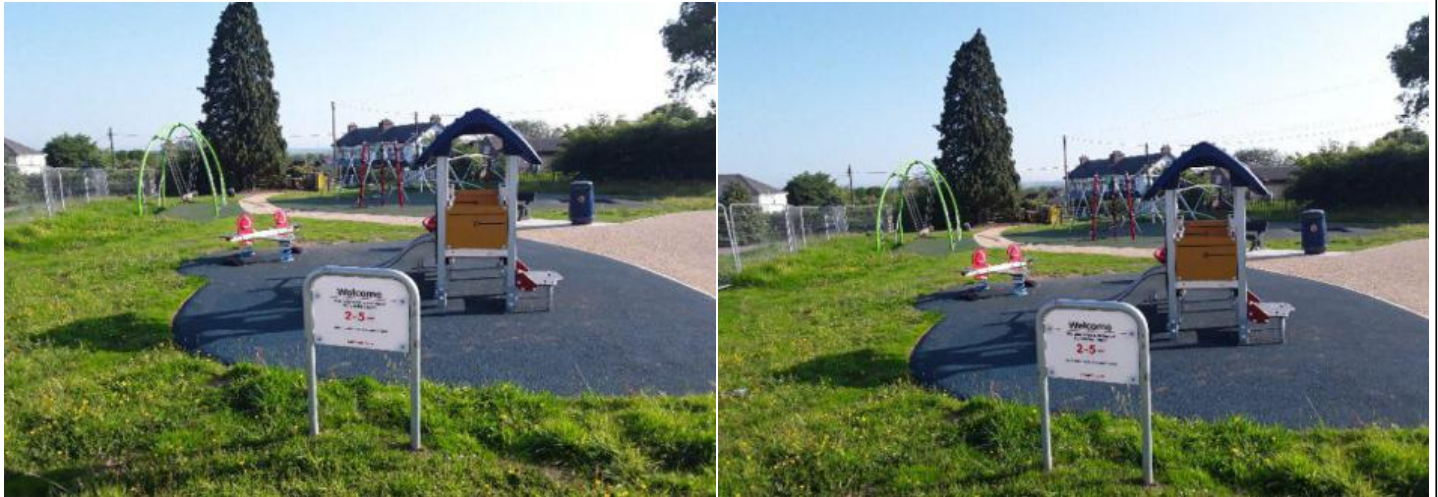
**Item:** Ancillary Items - Site General  
**Manufacturer:** Owner/Operator

**Finding:** It is recommended that signage, with information including the site address, contact information for maintenance issues and emergency contact details are provided for the facility

**Action:** Provide in accordance with the recommendations

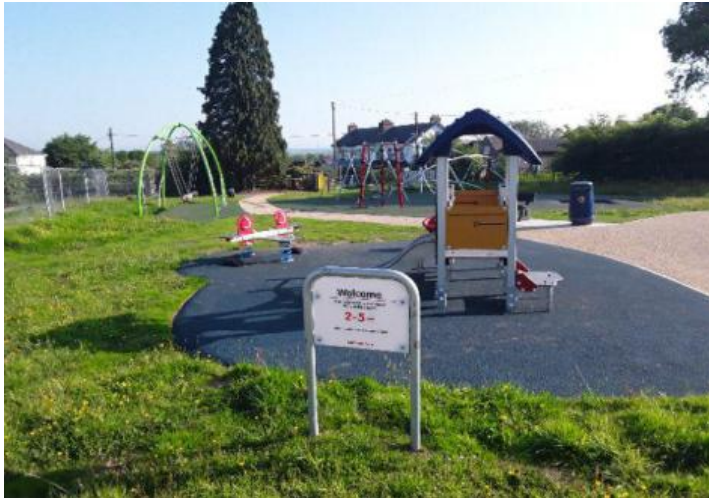
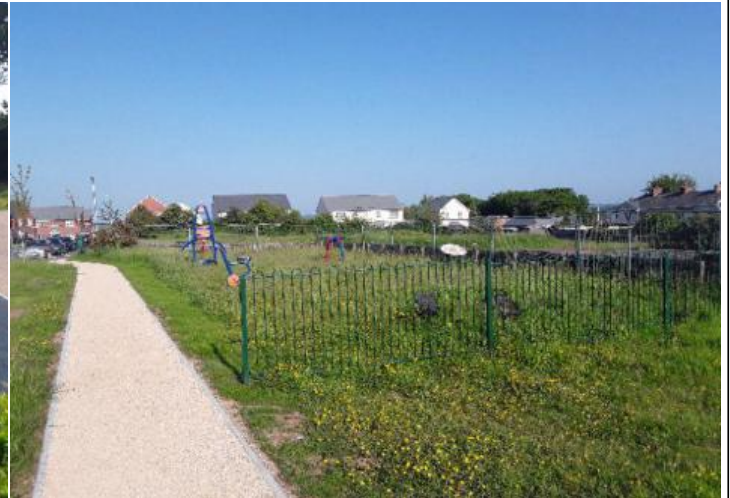
**Item:** Ancillary Items - Site General  
**Manufacturer:** Owner/Operator

**Finding:** The separation between the play equipment and fitness equipment is approximately 15m; the areas are segregated by a bow top fence however the fitness equipment is located adjacent to the play area access footpath presenting some potential for use by younger children

**Action:** Monitor use and ensure that there is an appropriate design risk assessment in place

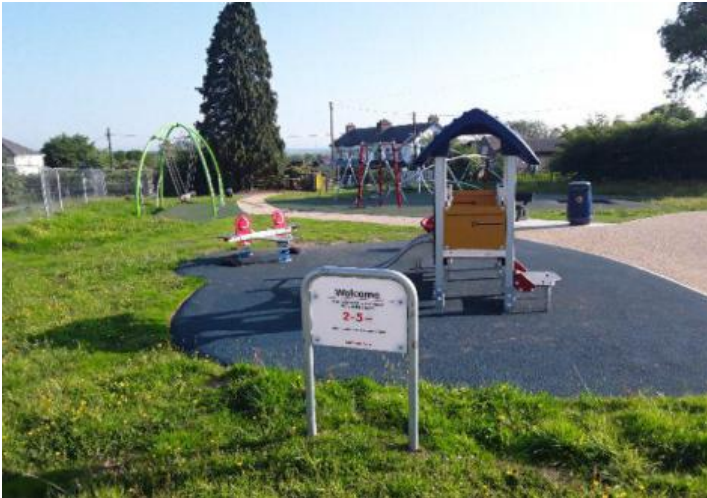
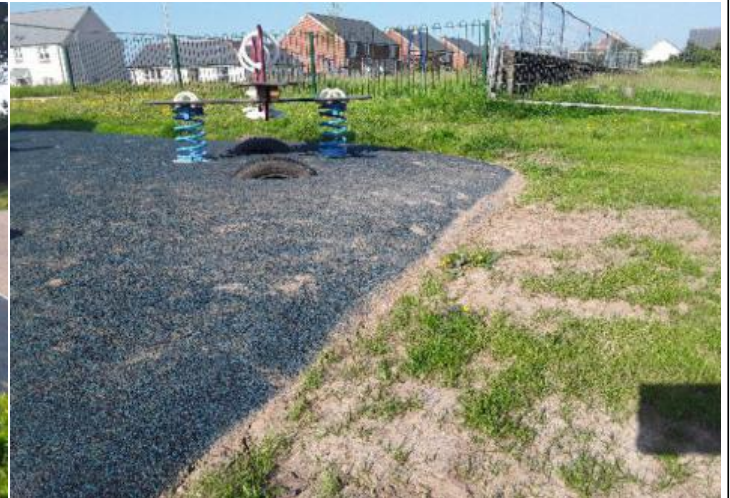
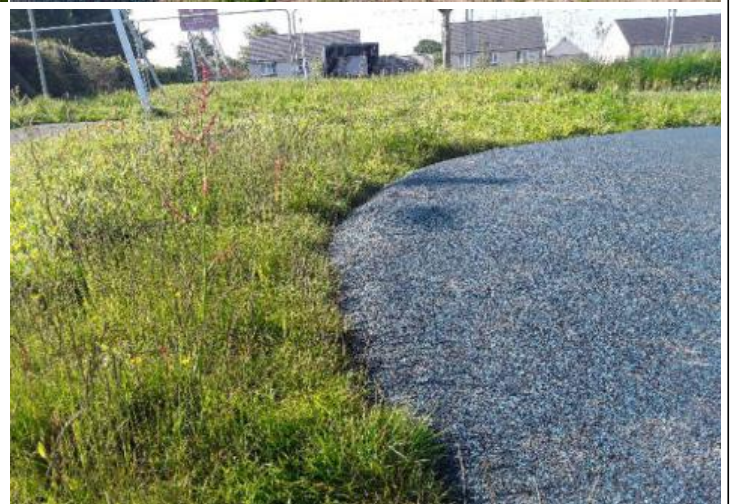
**Item:** Ancillary Items - Site General  
**Manufacturer:** Owner/Operator

**Finding:** The surface is uneven in places around the edges of the wet pour surface and the trenched edges could cause ankle roll injuries  
**Action:** Build up surfaces to remove trips

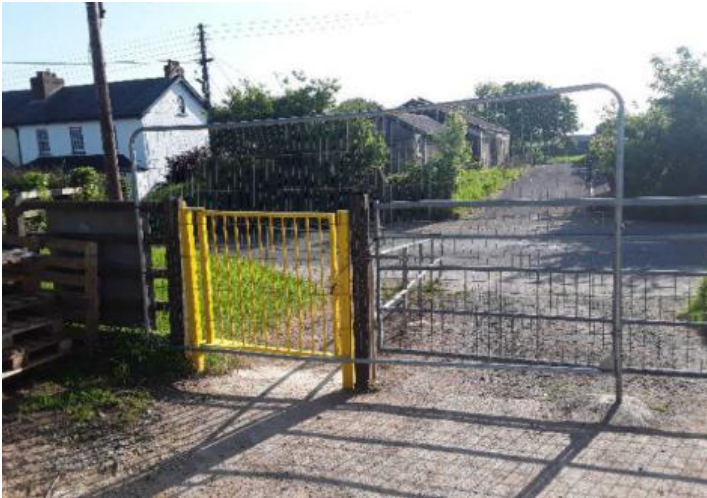
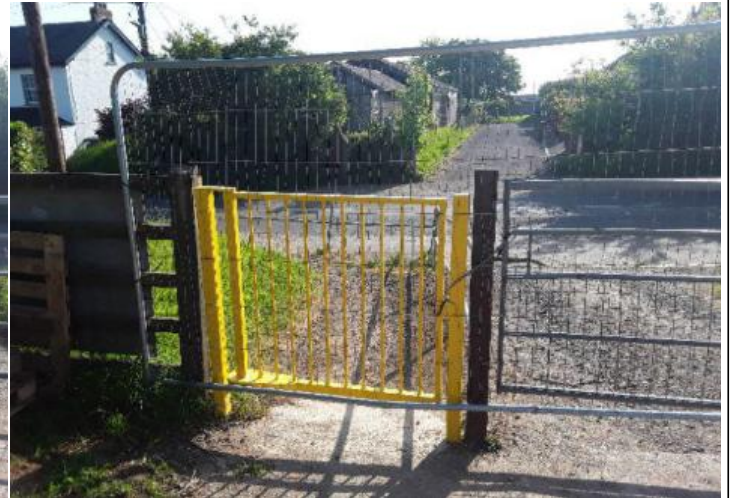
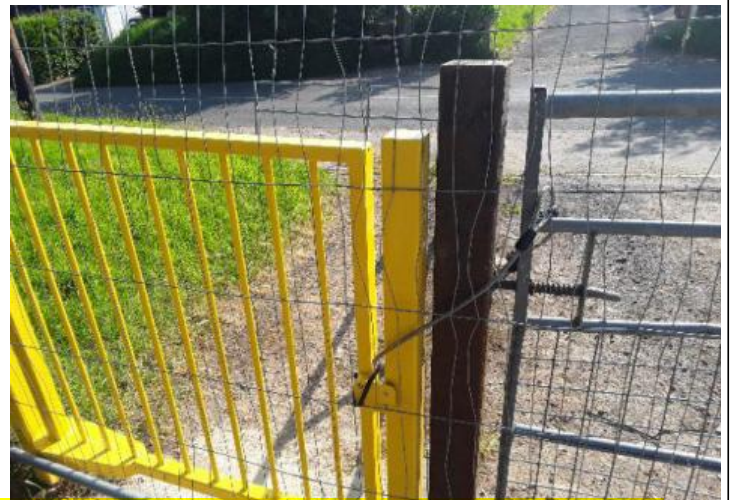
**Item:** Gates - Gate - Self Closing  
**Manufacturer:** I.A.E. Fencing

**Finding:** The gate/s was / were locked or secured at the time of the inspection and a full inspection could not be undertaken

**Action:** Complete inspection of gate/s when re-opened

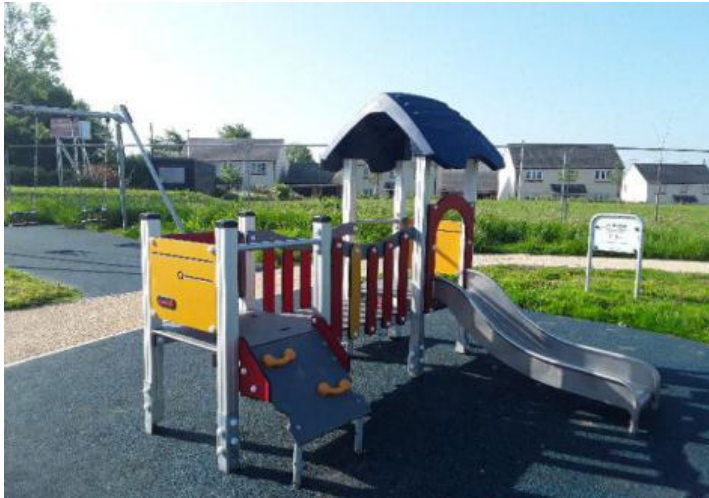
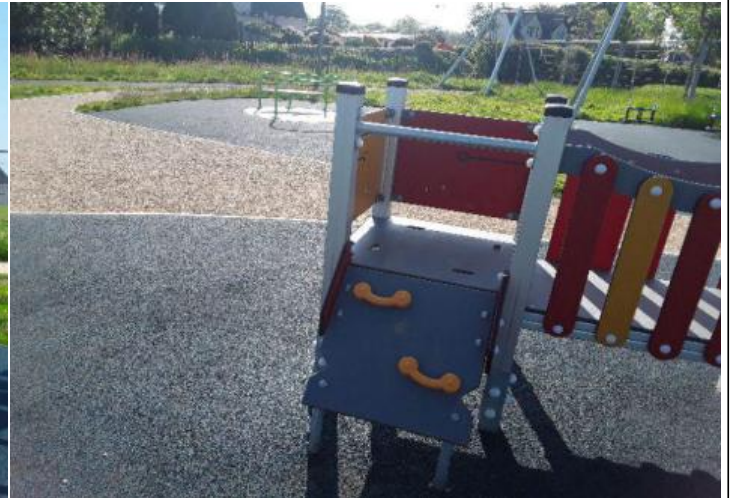
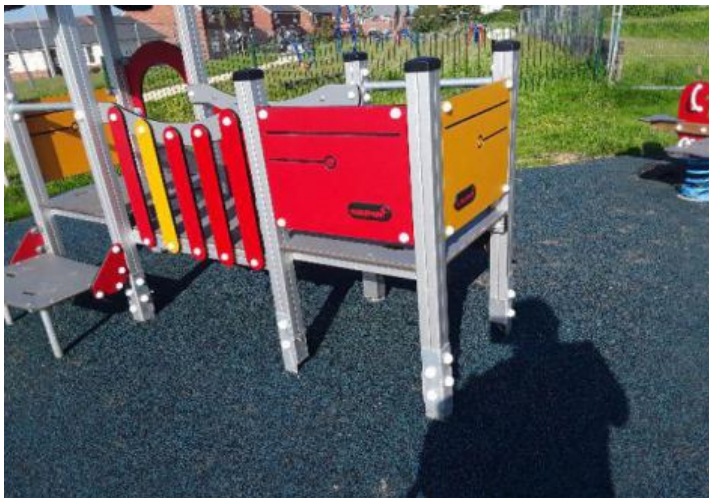
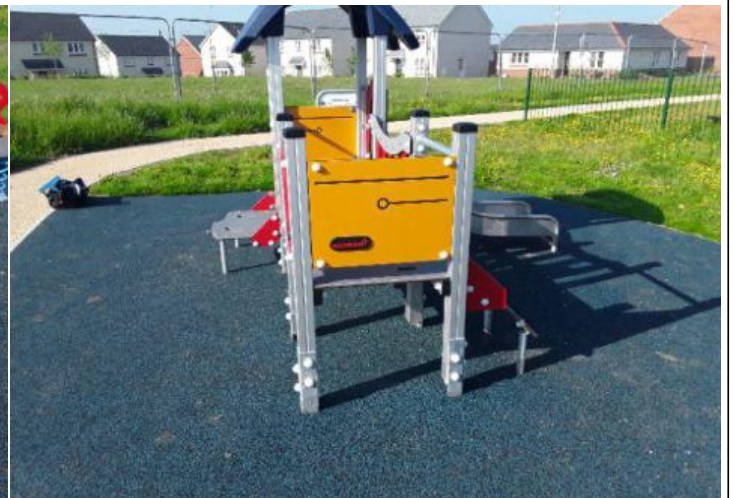
**Item:** Activity Equipment - Multi Play (Toddler)  
**Manufacturer:** Kompan Ltd

**Finding:** The item has been installed marginally too high which has resulted in the platform height being in excess of 600mm (630mm) and technically, the height of the barriers (550mm) are now insufficient to meet the requirements of BS EN 1176 Part 1. This is however a very low risk technicality and no remedial action is recommended as it has not affected the risk assessment of the item

**Action:** No action given the risk assessment

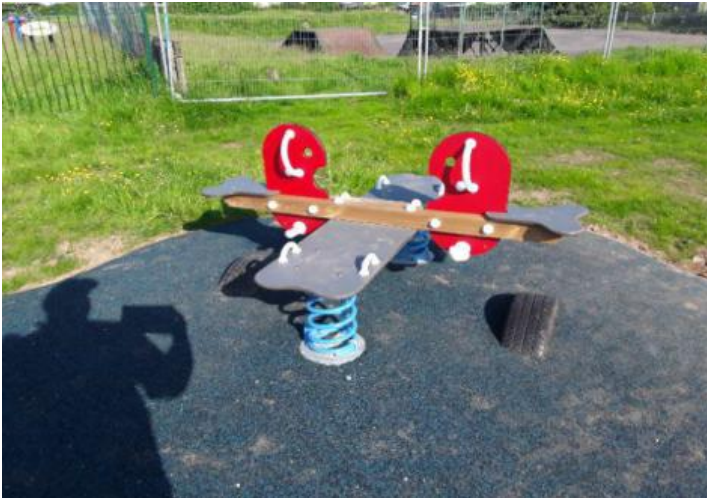
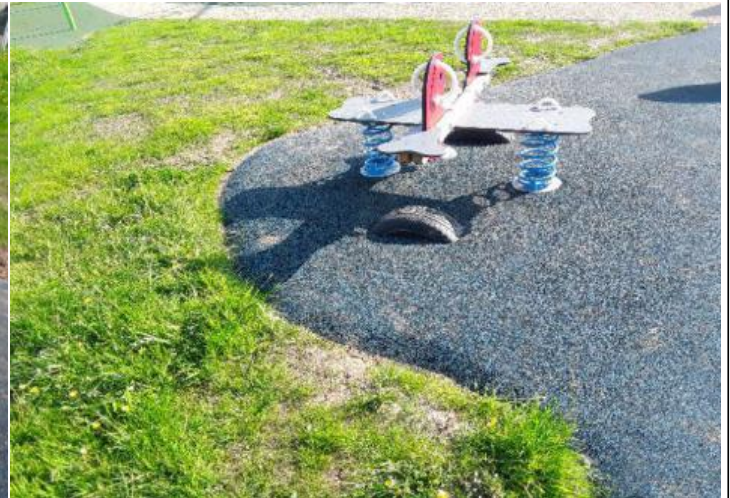
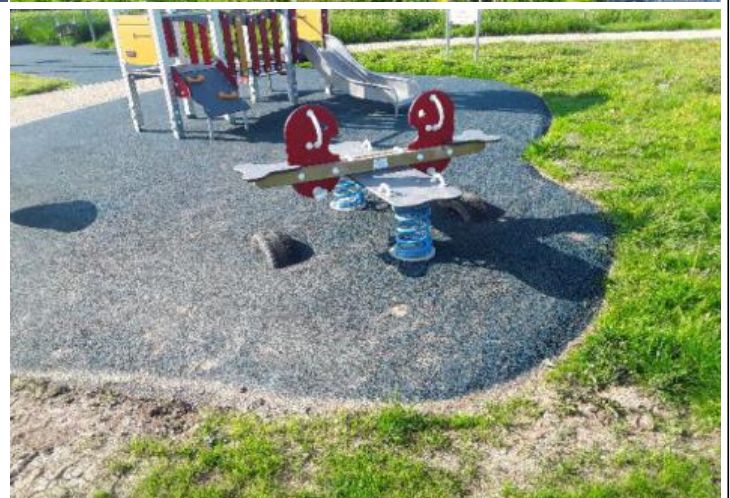
**Item:** Rocking Equipment - Spring See-Saw  
**Manufacturer:** Kompan Ltd

**Finding:** The grass surface forms part of the impact area around the equipment and the surface has not yet established

**Action:** Ensure that a suitable impact attenuating surface is established

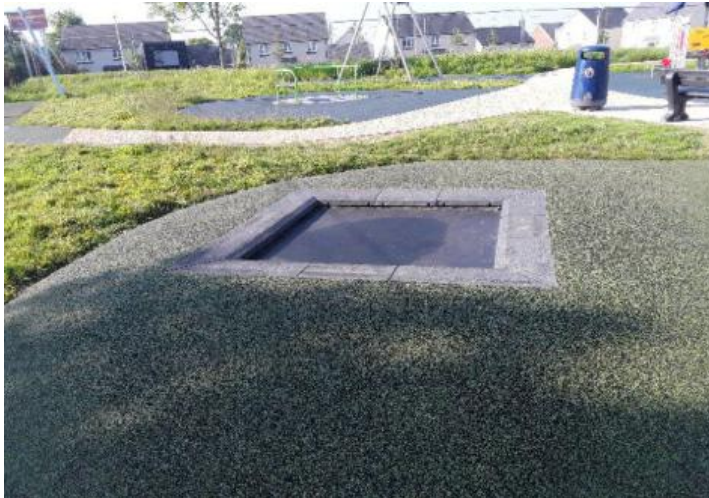
**Item:** Other - Bouncing Facility  
**Manufacturer:** Kompan Ltd

**Finding:** On site visits it is not possible to test the ground clearance of the Bouncing Facility bed as specified in BS EN 1176; ensure that the clearance between the Bouncing Facility Bed and the ground underneath is in accordance with the manufacturers recommendations

**Action:** Refer to the manufacturers recommendations
