Post Installation Report

Witheridge Parish Council

Witheridge Adventure Playground

Inspection Ref: 2061667

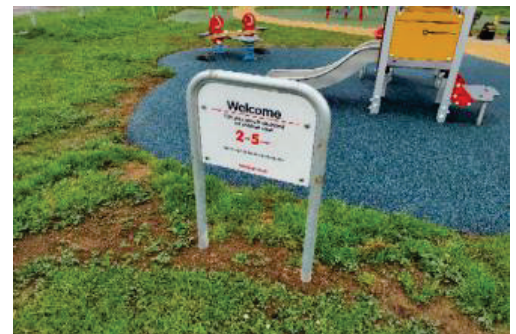
Item: Sign
Manufacturer: Kompan Ltd
Surface Type: Grass
Item Quantity: 1
Equipment Compliance: N/A
Surface Area Compliance: N/A

This item is satisfactory - no work required -

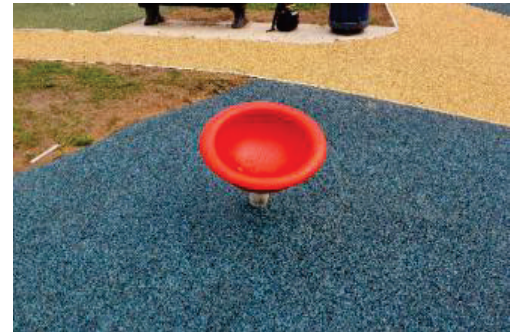
Item: Spinner Bowl
Manufacturer: Kompan Ltd
Surface Type: Wet Pour
Surface Nominal Depth: 80mm
Item Quantity: 1
Equipment Compliance: Yes
Surface Area Compliance: Yes
Total Findings: 1

This item is satisfactory - no work required -

i 4 - Very Low Risk

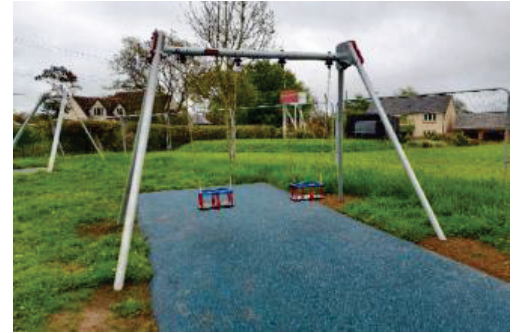
Item: 1 Bay 2 Seat (Cradle)
Manufacturer: Kompan Ltd
Surface Type: Wet Pour
Surface Nominal Depth: 65mm
Item Quantity: 1
Equipment Compliance: Yes
Surface Area Compliance: Yes
Total Findings: 1

This item is satisfactory - no work required -

i 4 - Very Low Risk

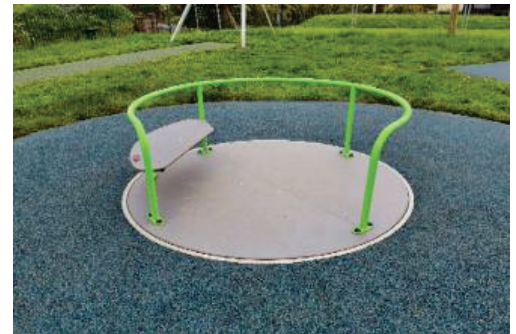
Item: Inclusive Roundabout
Manufacturer: Kompan Ltd
Surface Type: Wet Pour
Surface Nominal Depth: 55mm
Item Quantity: 1
Equipment Compliance: Yes
Surface Area Compliance: Yes
Total Findings: 1

This item is satisfactory - no work required -

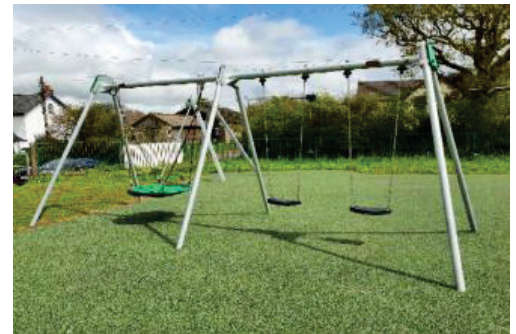
Item: 2 Bay 2 Flat 1 Basket Seat
Manufacturer: Kompan Ltd
Surface Type: Wet Pour
Surface Nominal Depth: 45mm
Item Quantity: 1
Equipment Compliance: Yes
Surface Area Compliance: Yes
Total Findings: 1

This item is satisfactory - no work required -
