## Post Installation Report

Witheridge Parish Council

Witheridge Adventure Playground

Inspection Ref: 2075206

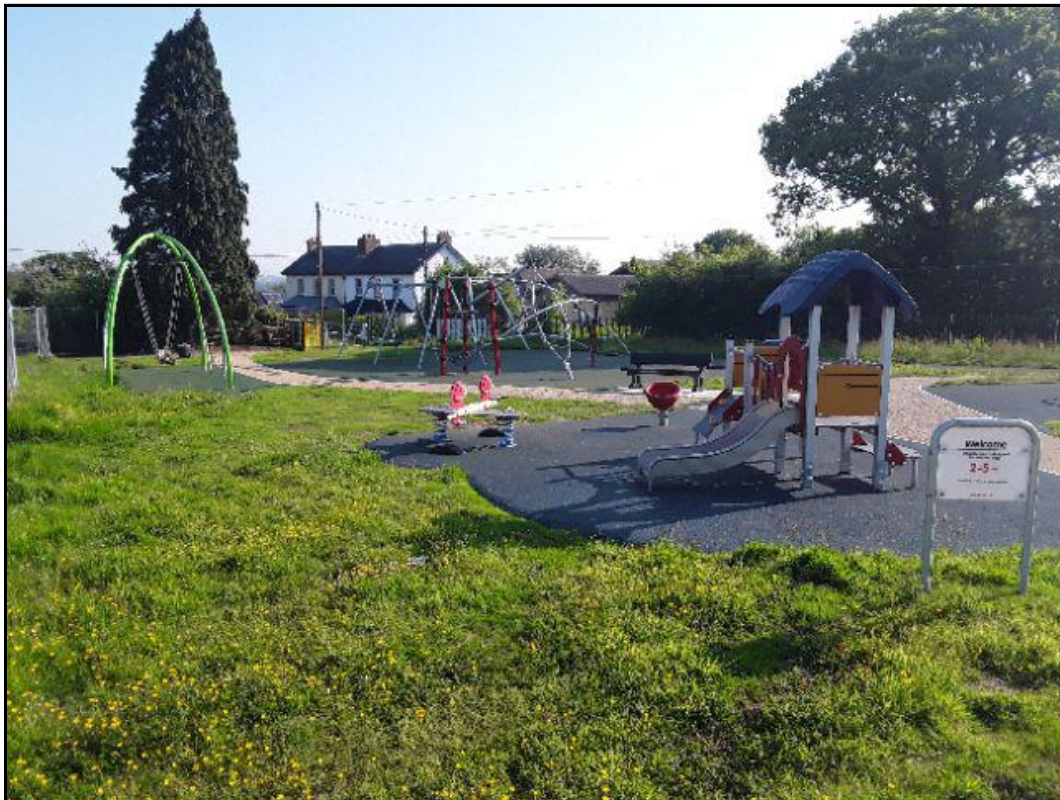
The site is partially overlooked by properties in the local community

The surface is uneven in places around the edges of the wet pour surface and the trenched edges could cause ankle roll injuries - Build up surfaces to remove trips

It is recommended that signage, with information including the site address, contact information for maintenance issues and emergency contact details are provided for the facility - Provide in accordance with the recommendations

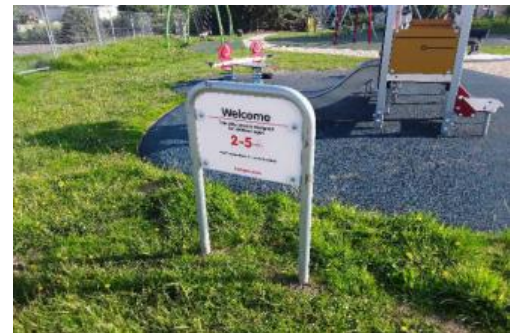
**Item:** Sign  
**Manufacturer:** Kompan Ltd  
**Surface Type:** Grass  
**Item Quantity:** 1  
**Equipment Compliance:** N/A  
**Surface Area Compliance:** N/A

This item is satisfactory - no work required -

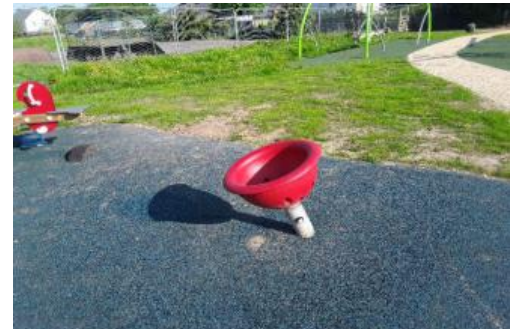
**Item:** Spinner Bowl  
**Manufacturer:** Kompan Ltd  
**Surface Type:** Wet Pour  
**Surface Nominal Depth:** 80mm  
**Item Quantity:** 1  
**Equipment Compliance:** Yes  
**Surface Area Compliance:** Yes  
**Total Findings:** 1

This item is satisfactory - no work required -

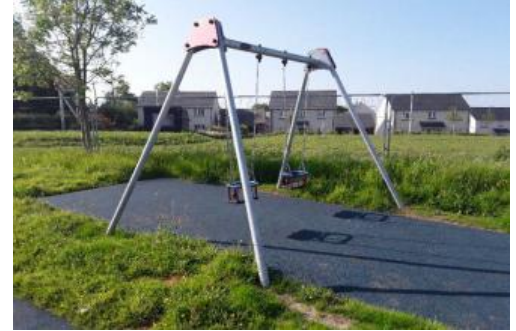
**Item:** 1 Bay 2 Seat (Cradle)  
**Manufacturer:** Kompan Ltd  
**Surface Type:** Wet Pour  
**Surface Nominal Depth:** 65mm  
**Item Quantity:** 1  
**Equipment Compliance:** Yes  
**Surface Area Compliance:** Yes  
**Total Findings:** 1

This item is satisfactory - no work required -

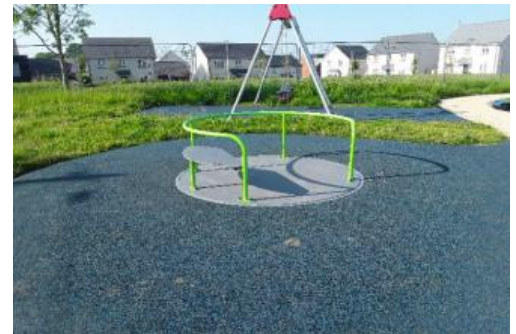
**Item:** Inclusive Roundabout  
**Manufacturer:** Kompan Ltd  
**Surface Type:** Wet Pour  
**Surface Nominal Depth:** 55mm  
**Item Quantity:** 1  
**Equipment Compliance:** Yes  
**Surface Area Compliance:** Yes  
**Total Findings:** 1

This item is satisfactory - no work required -

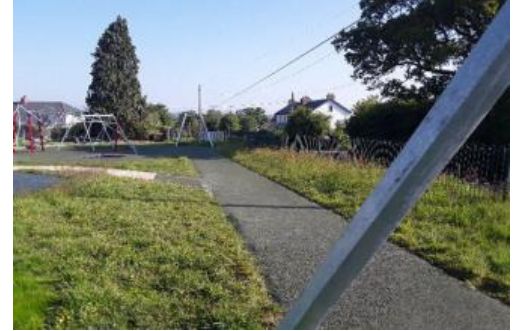
**Item:** Cable Runway  
**Manufacturer:** Kompan Ltd  
**Surface Type:** Mixed Surface  
**Surface Nominal Depth:** 55mm  
**Item Quantity:** 1  
**Equipment Compliance:** Yes  
**Surface Area Compliance:** Yes  
**Total Findings:** 1

This item is satisfactory - no work required -

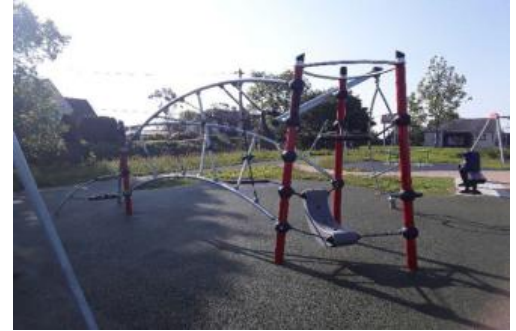
**Item:** Climbing Frame  
**Manufacturer:** Kompan Ltd  
**Surface Type:** Wet Pour  
**Surface Nominal Depth:** 135mm  
**Item Quantity:** 1  
**Equipment Compliance:** Yes  
**Surface Area Compliance:** Yes  
**Total Findings:** 1

This item is satisfactory - no work required -

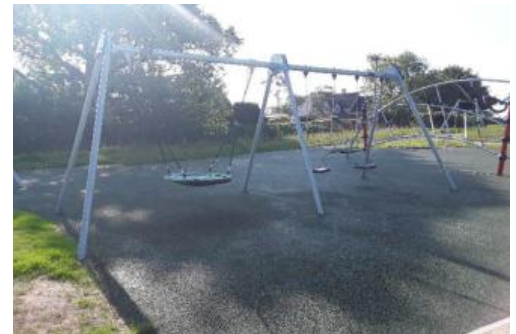
**Item:** 2 Bay 2 Flat 1 Basket Seat  
**Manufacturer:** Kompan Ltd  
**Surface Type:** Wet Pour  
**Surface Nominal Depth:** 45mm  
**Item Quantity:** 1  
**Equipment Compliance:** Yes  
**Surface Area Compliance:** Yes  
**Total Findings:** 1

This item is satisfactory - no work required -
